RSA
ENGINEERING & RISK CONTROL
SERVICES

MSBA
RISK MANAGEMENT

TO ALL MANITOBA SCHOOLS**DO YOU HAVE AN AIR RECEIVER WITH EITHER OF THE FOLLOWING CRNs (CANADIAN REGISTRATION NUMBERS)?**

E2573.1234567890
E1646.503674819

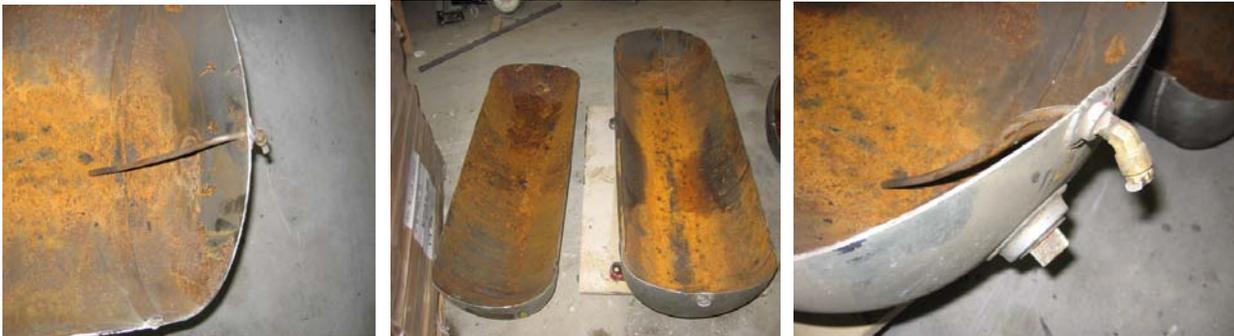
The following photos are of the Pembina Trails S.D. receiver

As previously indicated, the receivers were built with an internal drain pipe extending downward from the centre ½ inch opening on one of its heads. Although the drain lines were angled downward, they were not held in place and did not extend all the way to the bottom of the receivers, therefore, moisture and debris could not be drained properly. Consequently, moisture and sediment accumulated to a depth of about 1½". Eventually, the receivers corroded, leading to pitting and leaking from the inside bottom of the receiver. There is no doubt that the shell thickness (bottom section) becomes compromised which can lead to an explosion. The tanks were equipped with a 3/8" opening at the bottom but these were not used. The bottom openings would have been a better choice for draining the receivers.

After almost 40 or so years of service, it is recommended that all such air receivers be taken out of service. In the interest of safety to students and staff, and for continued uninterrupted operation, this should be done as soon as possible. The exception would be if the drain in the receiver's bottom was used to drain the moisture away. It is then less likely the integrity of the shell material has been compromised.
